Archaeological Addendum to the Archaeological Assessment for the Extension to the Sarjeant Art Gallery, Pukenuamu Queen's Park, Site R22/440, Whanganui, for an Authority Application to HNZPT

Archaeology North Limited, Whanganui

July 2024

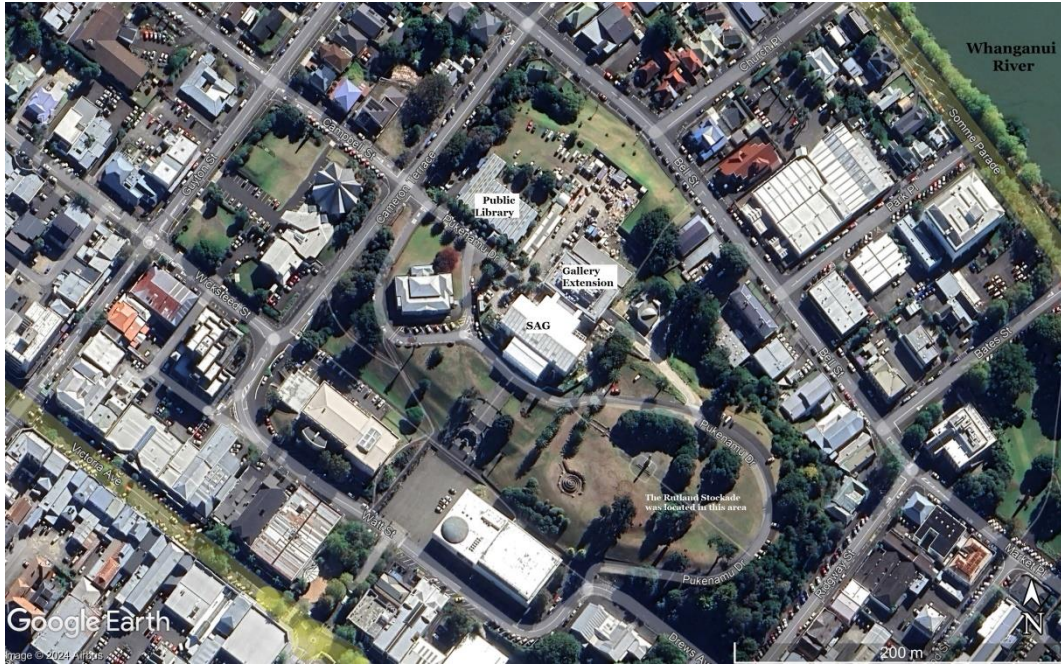
Figure 1: Google Earth image of the SAG site & PQP in central Whanganui with added labels showing the relevant buildings & the Whanganui River.

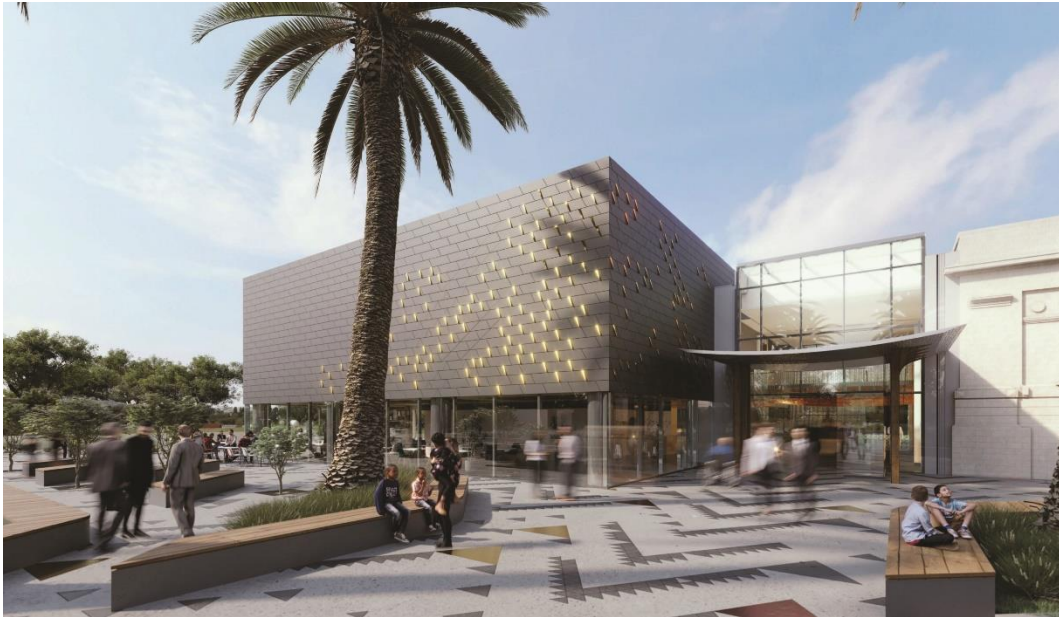
Figure 4: Concept vista looking north east showing the completed extension to the SAG, the new entrance & the maru (porch), as well as the paving planned to be installed. The SAG building made of white Ōamaru stone is just visible on the right. This area is covered by Authority 2020/457 (WDC, Warren & Mahoney).

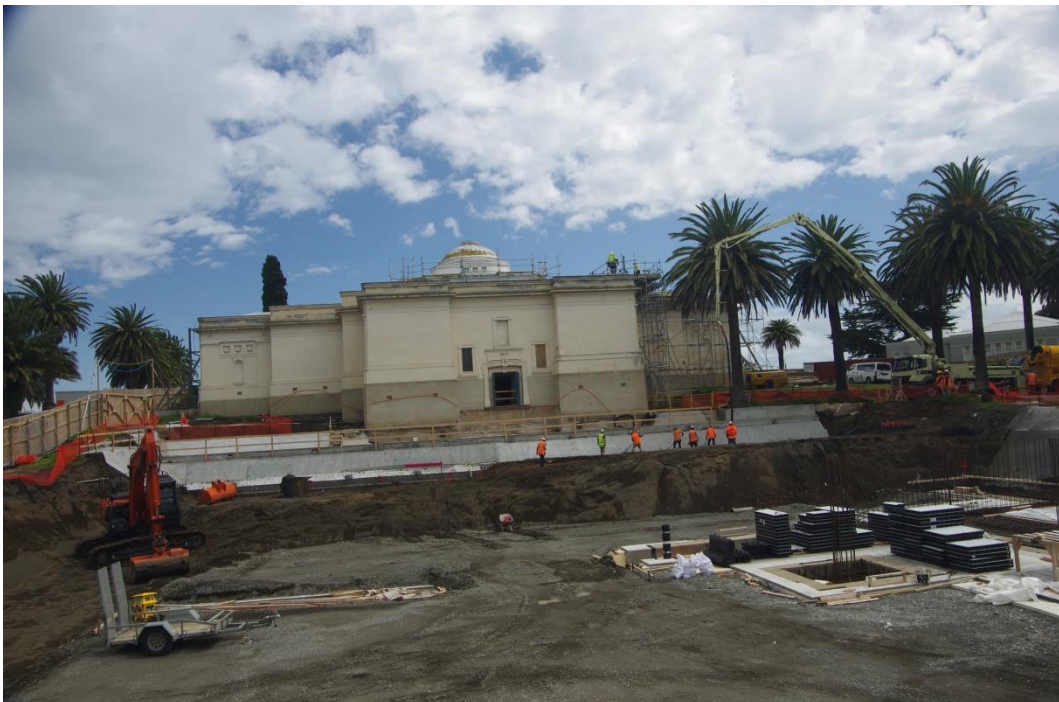
Figure 5: View showing the scale of the basement excavation at the SAG for the new building. Concrete is being poured for the beams across the back of the original SAG building. Cottage 1 (see report Section 3.0) was located to the right of the concrete workers in the image but the archaeologists were stood down at the time the photograph was taken for safety reasons as the concrete pump extended over their work area at the cottage site (Archaeology North Ltd.).

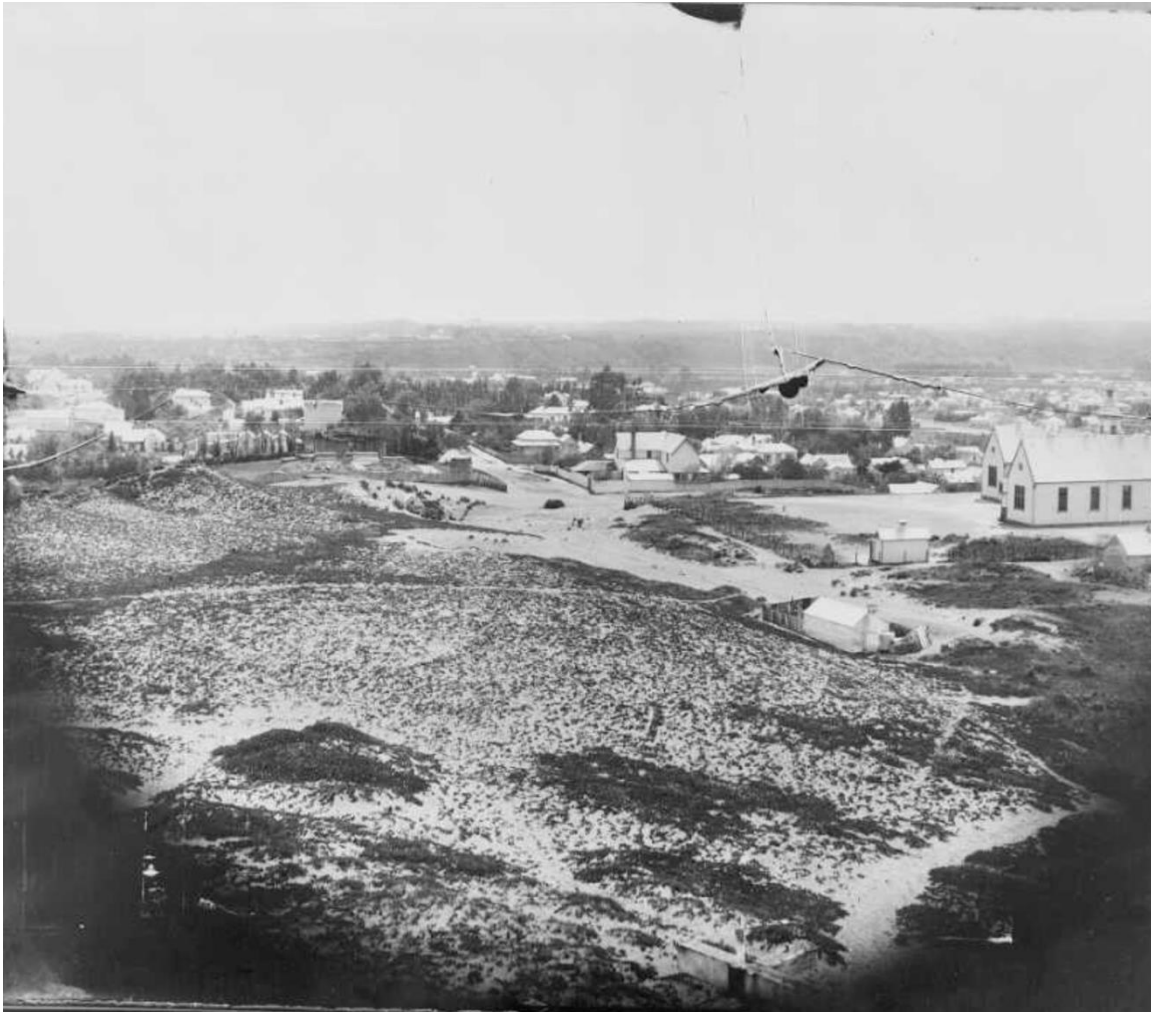
Figure 8: Photograph taken in 1884 showing Location One, the area affected by the current application that is now the location of Pukenuamu Drive & the Whanganui District Library. Figure 9 has the location of Campbell Street, Cameron Terrace, the Wanganui Girls' School & the approximate route of the proposed trenching marked on the same image.

The above image shows the Girl's High School (visible on the right) that was opened in 1879. It was the first of two schools built on the site. The school burnt down in 1917 three weeks before the foundation stone for the SAG was laid. In 1905 the school name was changed to Queen's Park School.

The Whanganui District Library is now located in front of where the school is located in the image. The cottages located near the school in the image were probably occupied by squatters.

The dune in the image foreground was cut down in the 1880s when the beautification & leveling of the park began. The tennis courts in the park had not been formed at the time the image was taken. (Alexander Turnbull Library, 1/2-011846-F).

An historic photograph from 1884 shows the sand dunes and a track in the affected area (Figures 8-9). The track visible in the image follows the approximate alignment of the clay feature found in the stormwater pipe trench. The image also shows the Wanganui Girls' School completed in 1879 that was located in the area between the present district library and top of the Bell Street slope. At least three timber cottages, probably occupied by squatters, are also visible in the figures.

The image in Figures 8 and 9 shows the area covered by the new Authority application including the intersection of Campbell Street/Pukenamu Drive and Cameron Terrace. A track running roughly north-south is faintly visible in the image running parallel to the school fence. The surfaces of the nearby roads are not formed and later earthmoving, and the formation of Pukenamu Drive, makes a full and direct comparison of the landscape difficult.

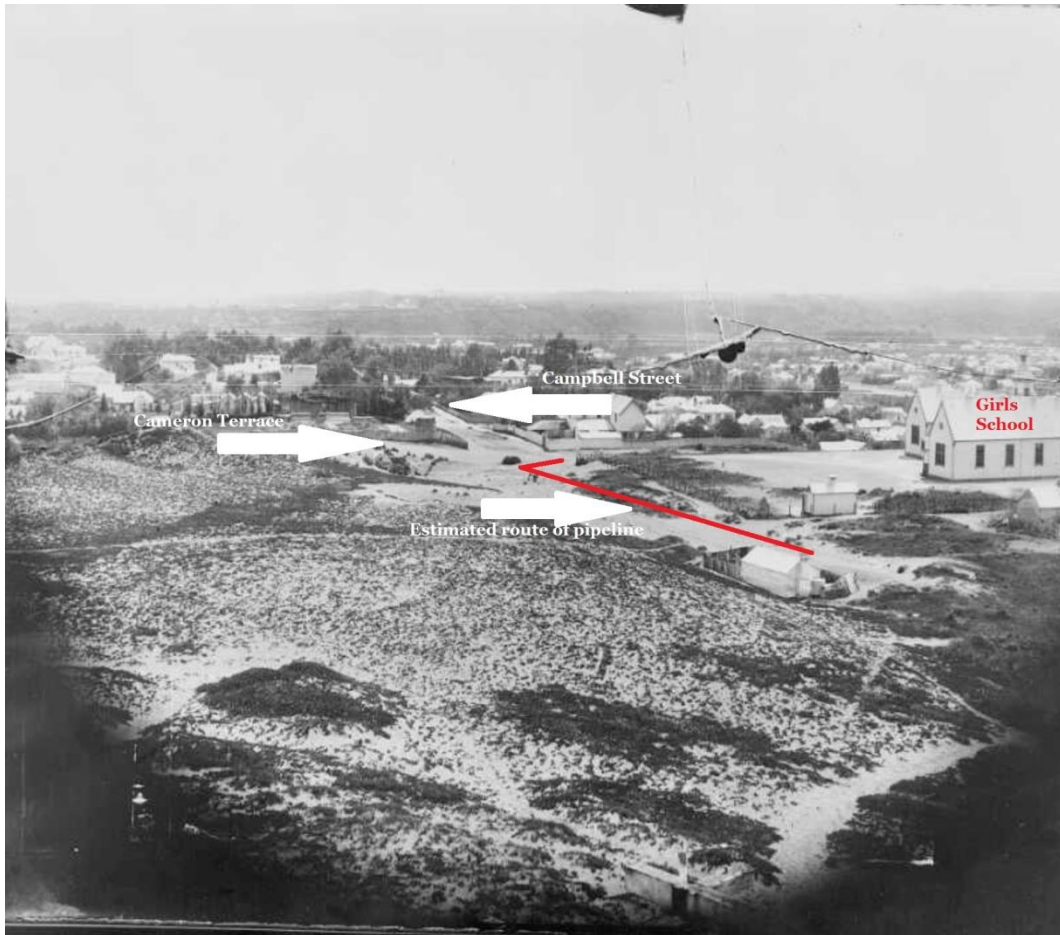
Figure 9: The same photograph as in Figure 8 with annotations by Archaeology North Limited showing the estimated route of the proposed pipeline, the location of Campbell Street & Cameron Terrace.

The red line shows the estimated route & the first section of the pipe to be installed in Pukenamu Drive & Cameron Terrace & then in to the old library carpark (Alexander Turnbull Library, 1/2-011846-F).

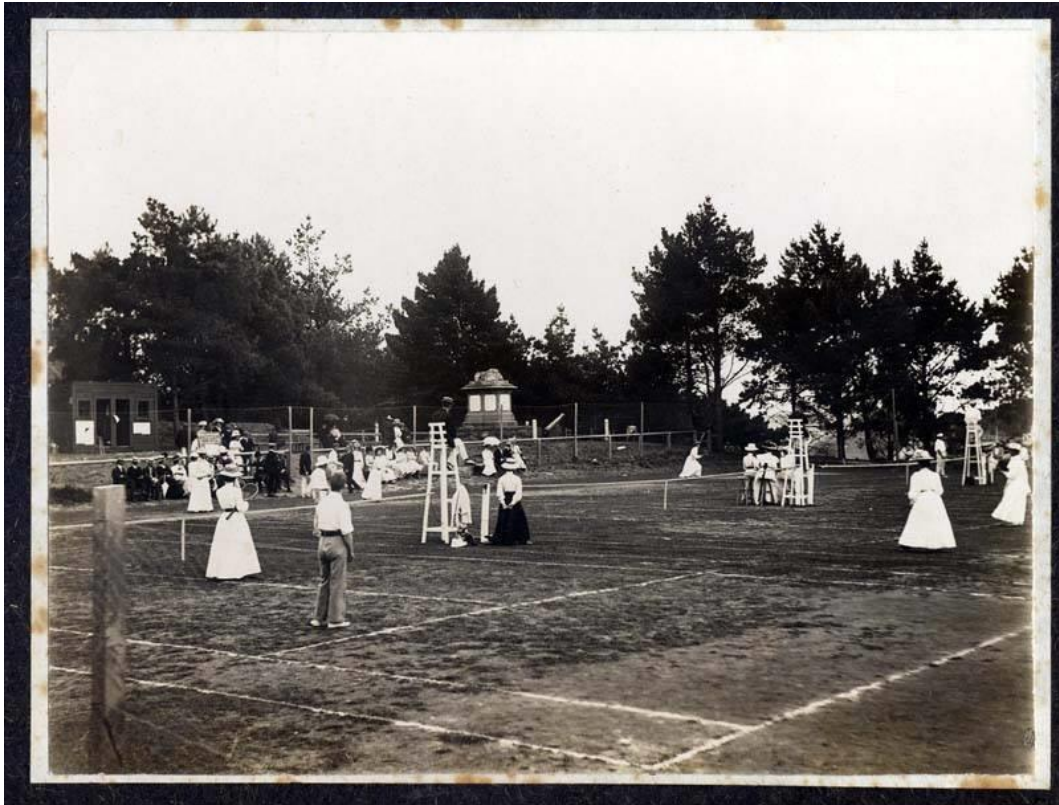
Figure 10: Showing the Queen's Park Tennis Club courts that once were located where the SAG was built in 1917-1919

The Lion Monument is clearly visible in the background located on the edge of the tennis court & the PQP hill where it was first located in 1892 over the grave of the 18 soldiers killed at Nukumaru.

The SAG front entrance faced was built where the Lion Monument had stood before it was moved down the hill. The monument was moved further down the hill before the Veteran Steps were built & before the gallery was opened in 1919.

The photograph was taken between about 1905-1910. Note the height of the pines (Whanganui Regional Museum).

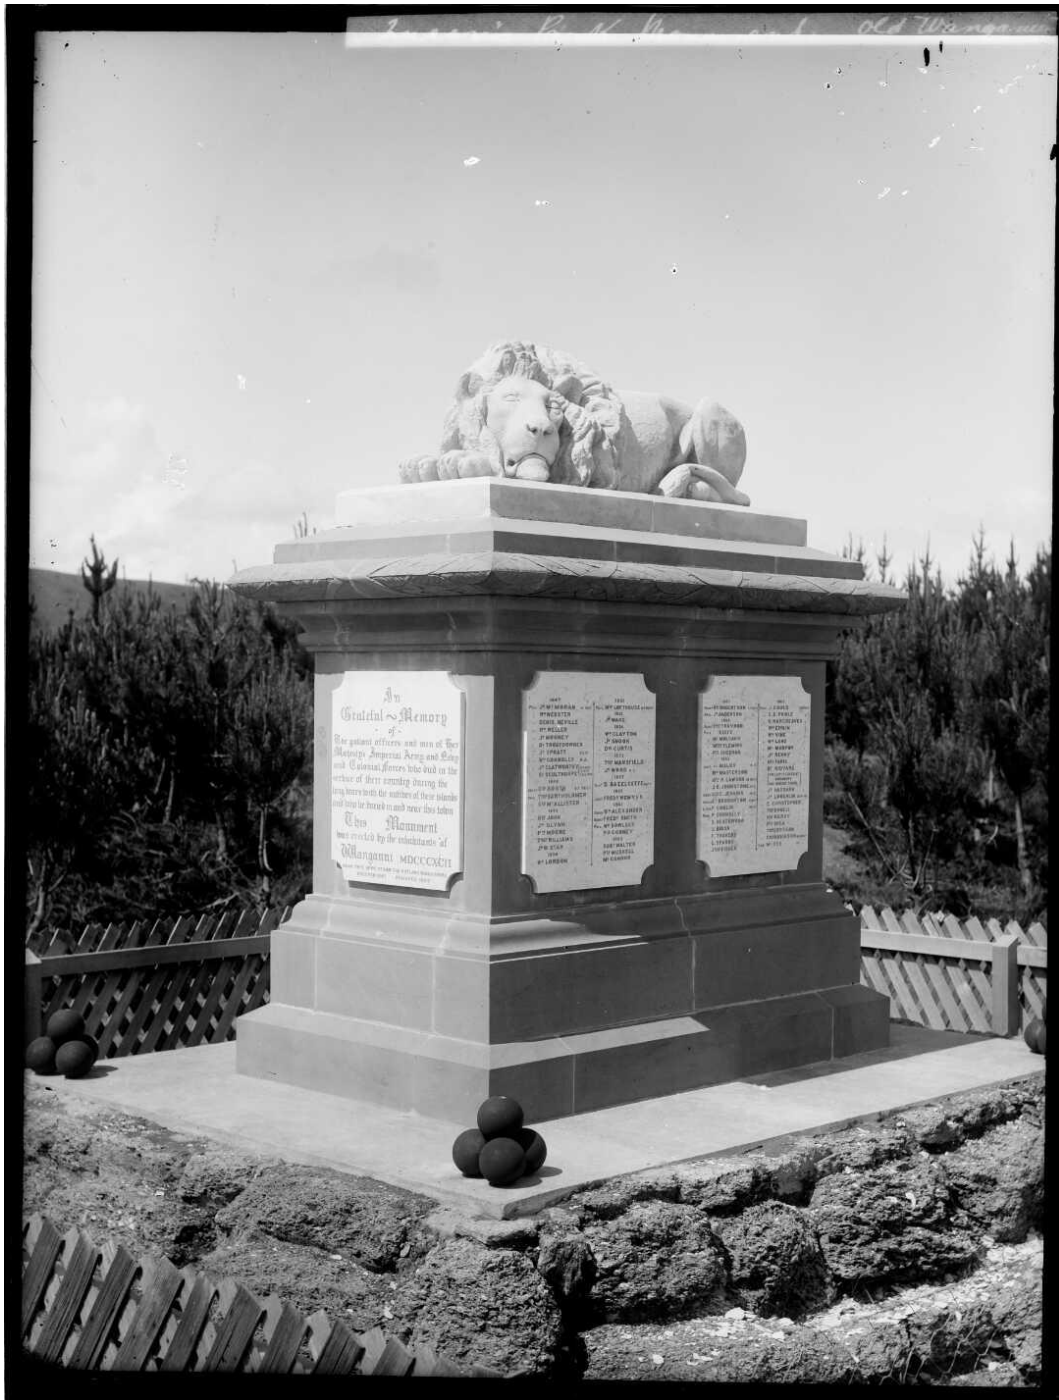
Figure 11: Photograph showing the Lion Monument where it was erected shortly after its completion in 1892. The image also shows the cannon balls, the original timber fence & the pine trees (Alexander Turnbull Library, 1/1-000052-G).

The area on Pukenamu Drive between the original front entrance to the SAG and top of the Veterans' Steps is the location where the Lion Monument or Memorial (now located further down the steps) was originally located (Figs. 11-13).

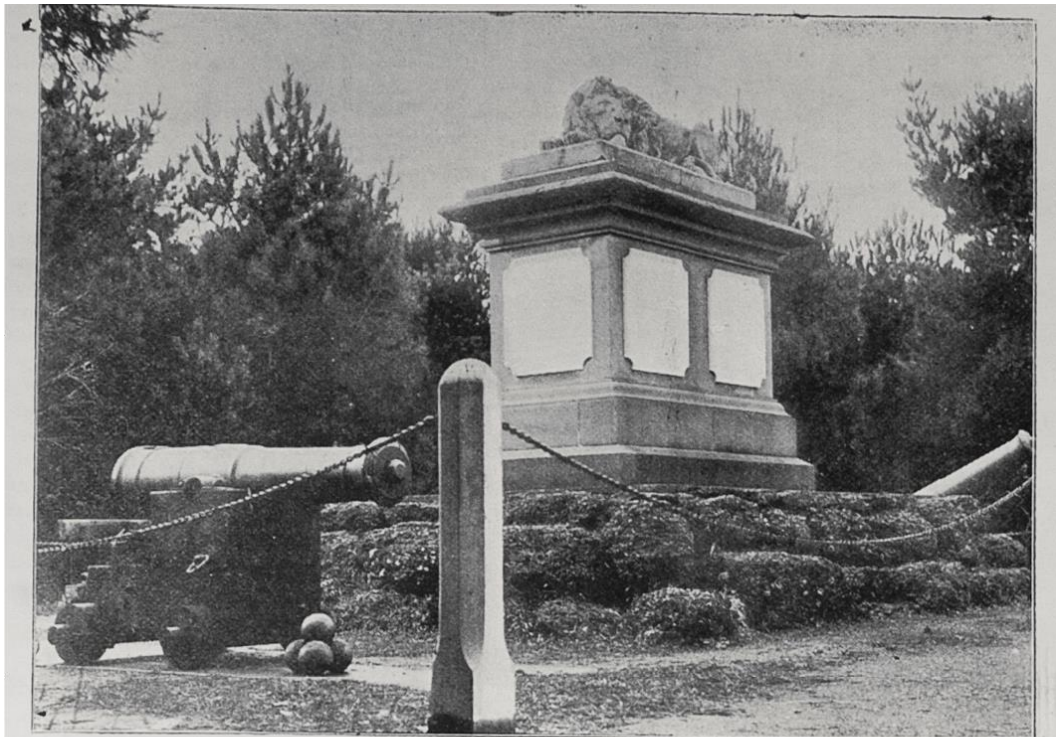
Figure 12: Photograph showing the Lion Monument in about 1900 with a chain fence & cannon on either side ([Auckland Weekly News](#), 15 August 1901, p.4, Auckland Libraries Heritage Collections AWNS-19010815-04-01).

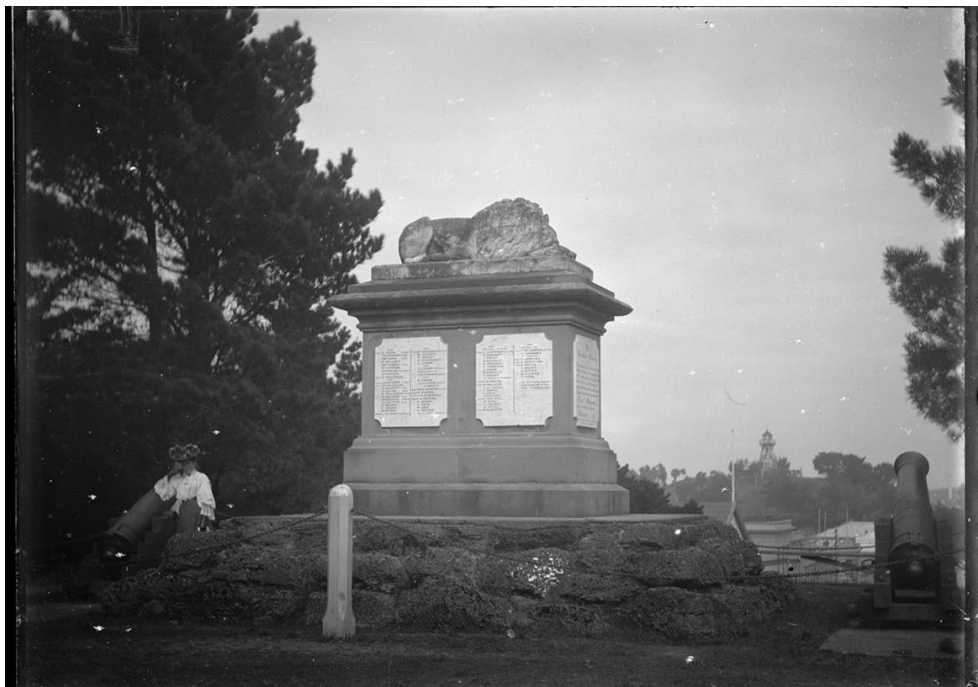
Figure 13: Photograph showing the Lion Monument erected early in the 20th Century before it was moved. The building with the flagpole is the old Drill Hall, located on the site of the present War Memorial Hall. The Bell Tower in Cooks' Gardens is visible in the distance. Note the pine tree growth compared to earlier images (Source of image unknown).

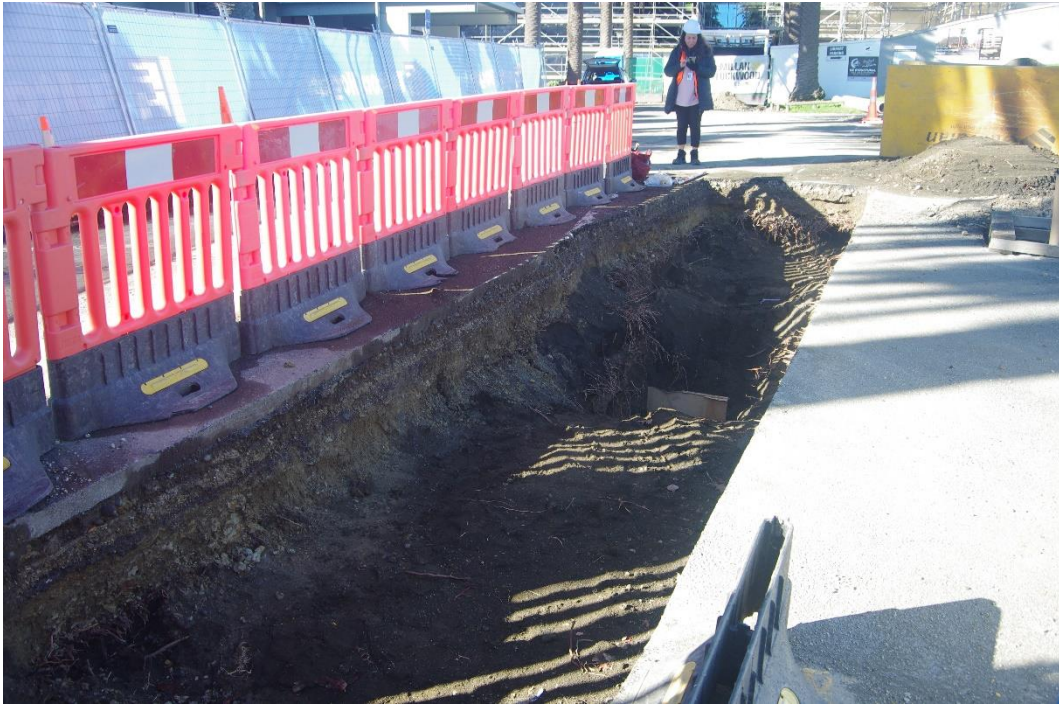
Figure 14: Showing the trench in Pukenamau Drive outside the front of the Whanganui District Library where the discovery of animal bones & ceramic material was made by workers at Location One (Archaeology North Ltd.).

Trenching in Pukenamu Drive in front of the Whanganui District Library for the installation of a stormwater pipe was stopped when a cluster of butchered beef bones were uncovered (Figs. 14-16). The bones are buried below the modern road and also below an early track that probably dates to the 19th century. The archaeological remains located are most likely associated with the Soldiers' Settlement, or perhaps the later squatter's occupation of what is now PQP. Both of these uses of the modern park date from the 19th century and are considered to be archaeological under the HNZPTA 2014.

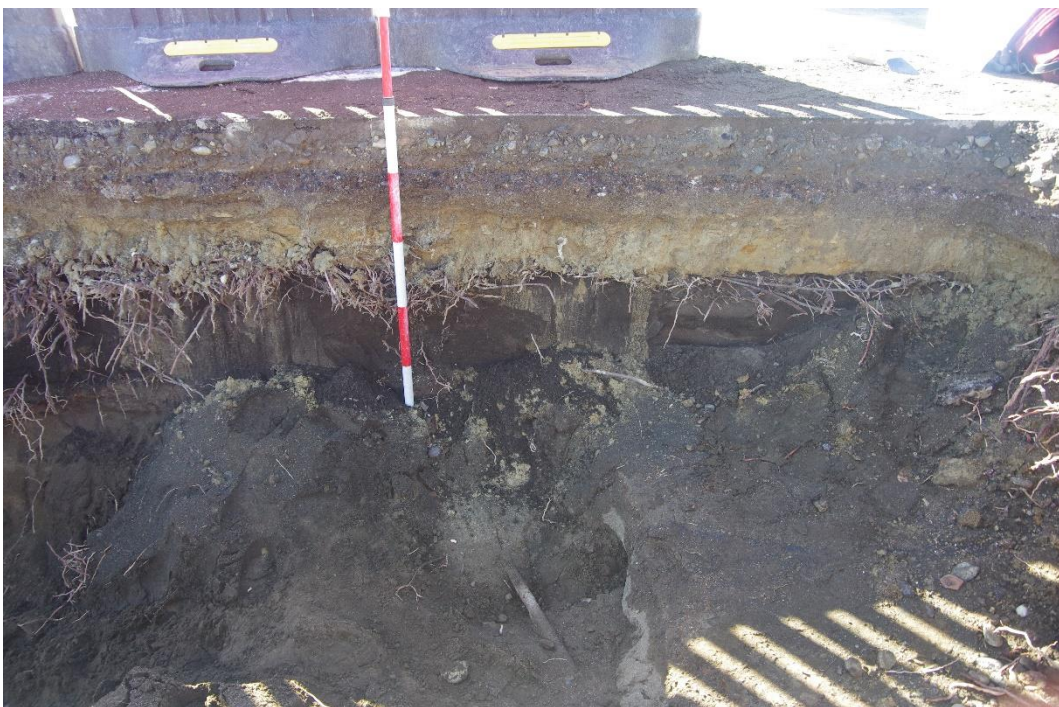
Figure 15: Showing the location of the discovery of the animal bones & ceramic material by workers in Location One under an old water pipe. It also shows the multiple lens of material that make up the modern road layer but the lower clay level is not visible (Archaeology North Ltd.).

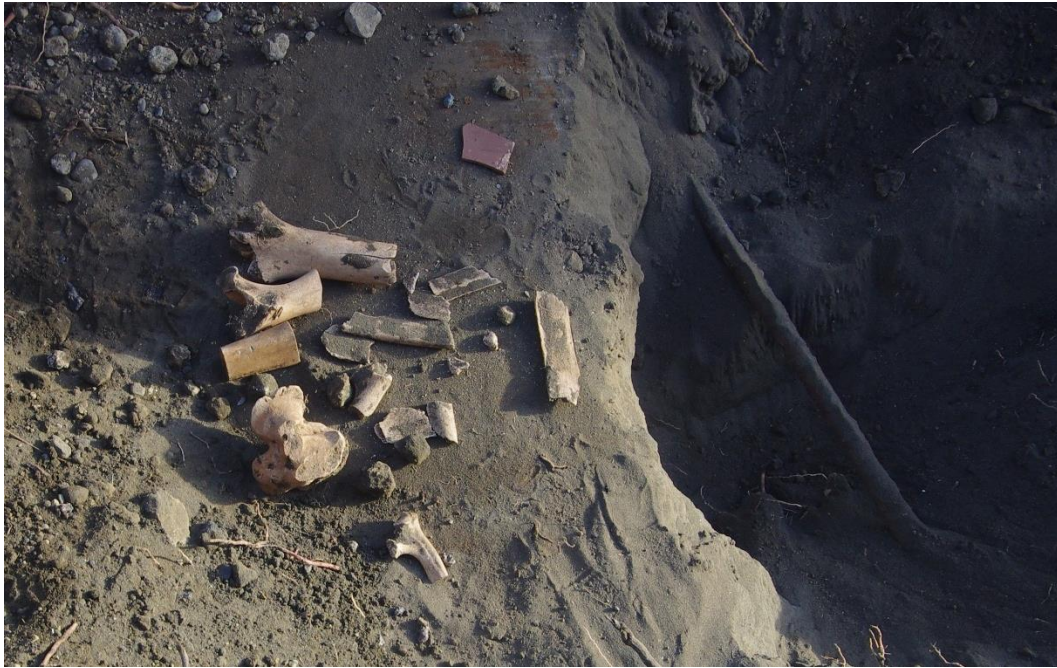
Figure 16: Showing the animal bones & ceramic material uncovered by workers in Location One, the trench under an old iron pipe in front of the Whanganui District Library in Pukenuamu Drive. The bones in the trench are lying on the rusty historic clay layer, which is just perceptible (Archaeology North Ltd.).

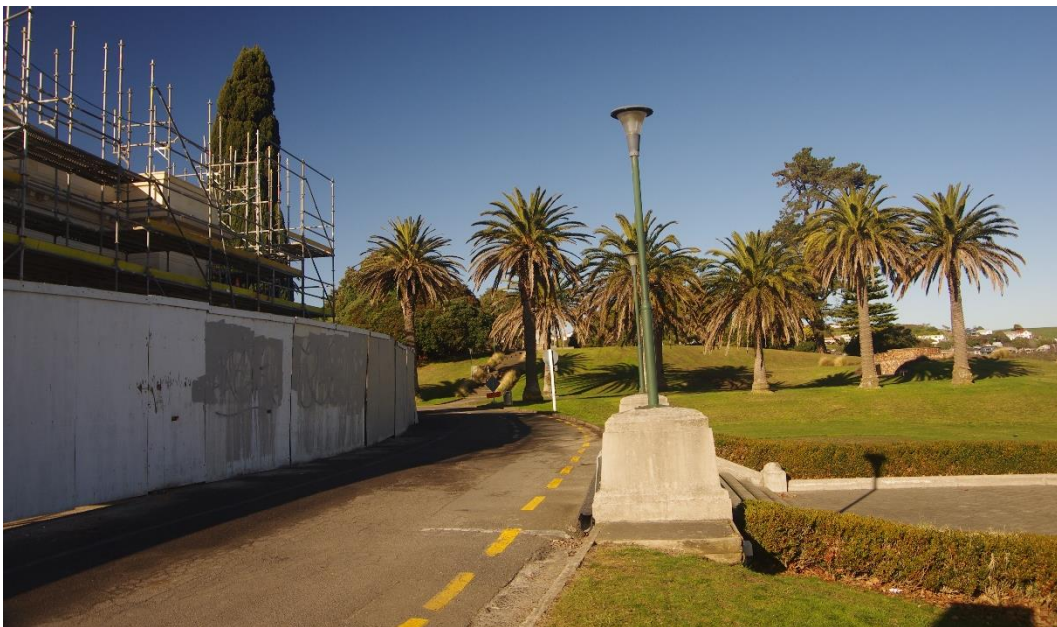
Figure 17: Showing Location Two, being the proposed location of trenching for the installation of lighting & security camera cables, in Pukenuamu Drive outside the original SAG main entrance & the top of the Veterans' Steps. The location is where the Lion Monument was built over the trench in which the remains of the soldiers were buried after they had been exhumed from their graves at Nukumarua where they were killed in fighting in 1865 (Archaeology North Ltd.).

All of the trench excavations for the lighting and camera cables on the road will have to be done using a mechanical digger or by hand. A digger will need to be onsite to remove the road surface. Attention will need to be paid for any evidence of the old monument foundations, the burial trench, and any bones that may have been left behind.
