**An Archaeological Assessment
of the Sarjeant Art Gallery Steps
Refurbishment, Queen's Park, R22/440,
Wanganui**

Michael Taylor

Archaeology North Ltd.,

October 2008

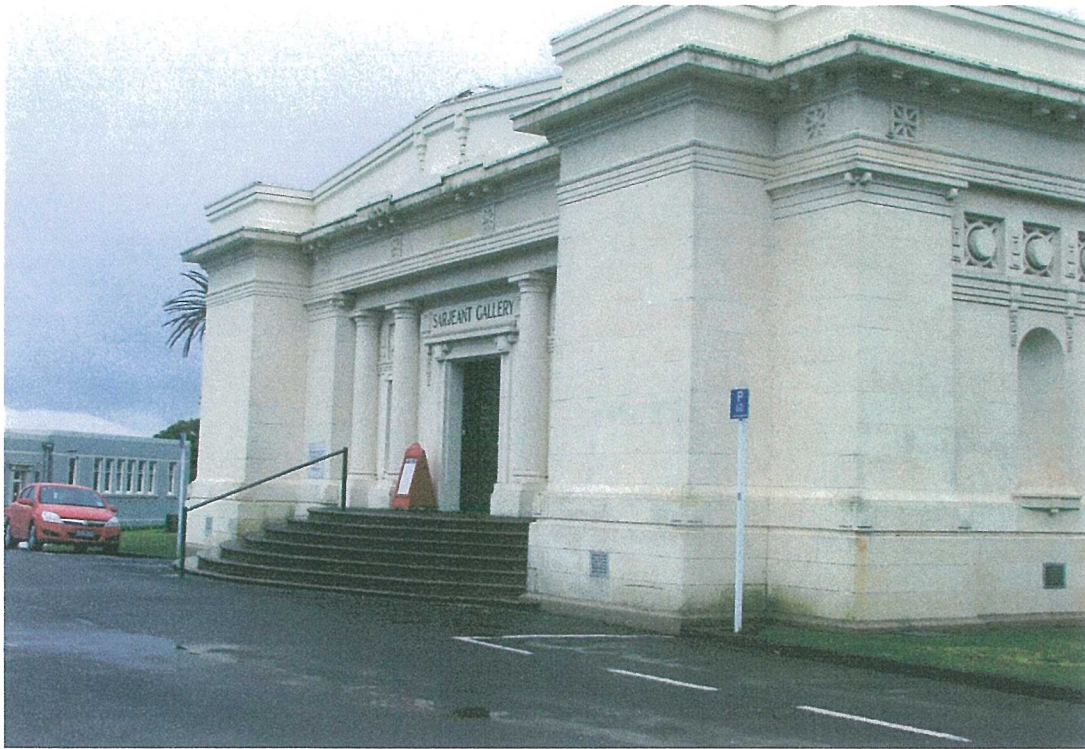
Photograph 1: The ground beside both front corners of the gallery (under grass and tarseal) will be affected by the construction of ramps and associated works.

The area with the greatest potential for in-situ archaeological material is at the front of the gallery where refurbishment includes the construction of wheel chair access ramps, landings and paths, and landscaping. If significant remains, such as for example small house or hut floors or rubbish holes are present they should be investigated. Scattered or more diffuse historic deposits are also possible if old buried historic ground surfaces are encountered.

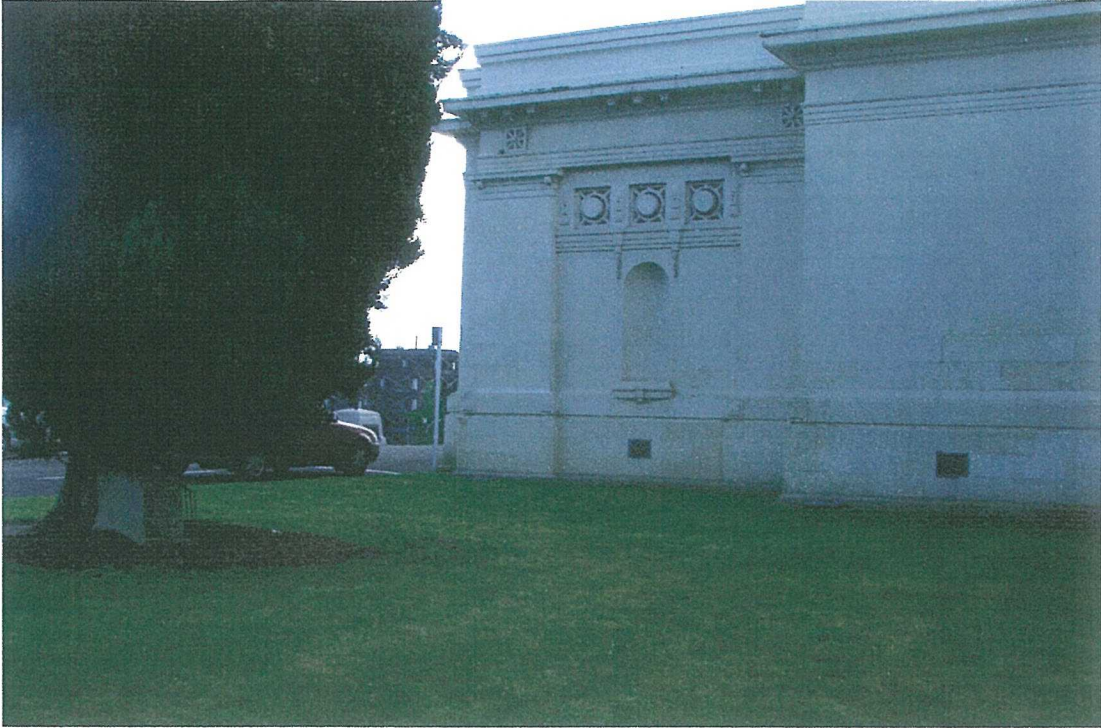
Photograph 3: Looking west towards the gallery corner at the level grassed and tarseal area that will be affected by the reburishment.

side of the gallery steps the road surface drops away while the grass area there is higher (Photograph 2), whereas on the right side of the gallery the road and ground surface are level (Photograph 3).

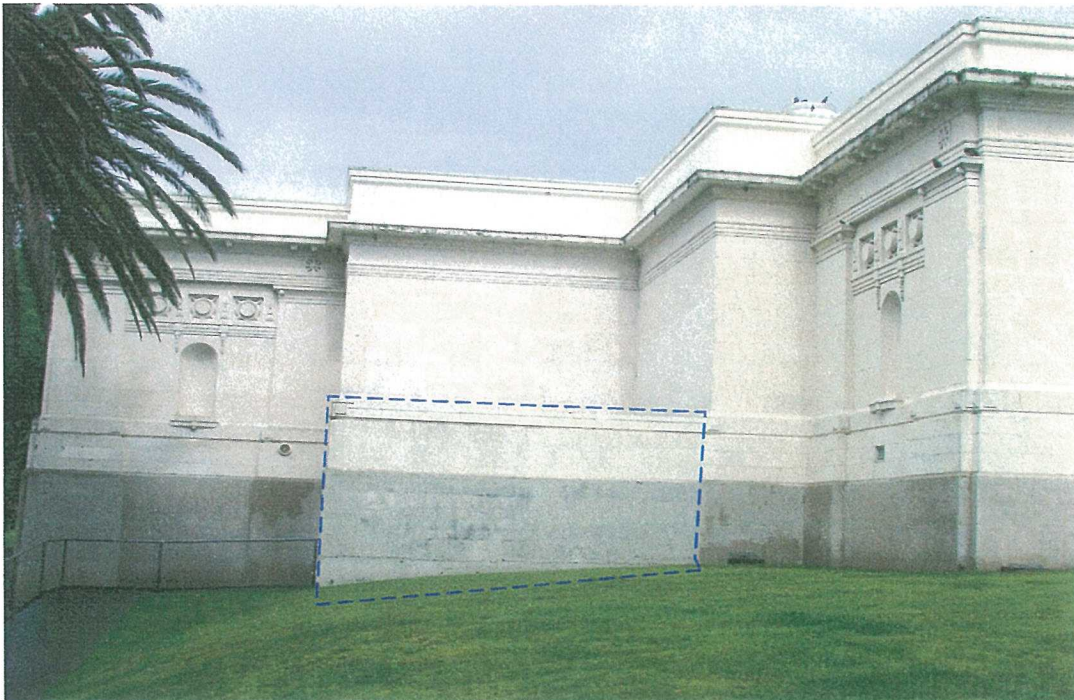
Photograph 4: View of the gallery back wall to be replaced where trenching will be required during the refurbishment.

At the rear of the gallery a trench needs to be excavated for the replacement of a block wall and footing (Fig. 1) where it is proposed to replace a concrete block wall requiring excavation of a 6m long trench, 1m wide and 0.9m deep (Photograph 4). Trenching to replace the wall will be necessary and will follow existing trench-lines but there is some potential to affect new ground and thereby exposing archaeological remains. The wall is part of a modern addition to the gallery.
